# SUBJECT PROPERTY: 15400 Perry St

Overland Park, KS 66223

## **REPORT NUMBER:** 071509-15400

**INSPECTION DATE:** 7/15/2009

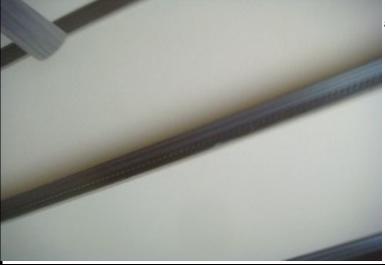
Painted wood trim with wall paint at Master Bedroom ceiling.

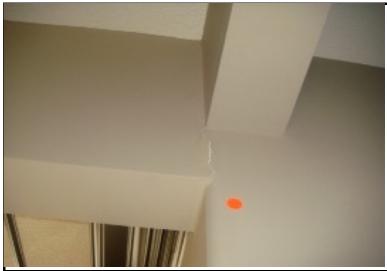
Repair cracked drywall surface at: upper level hallway.

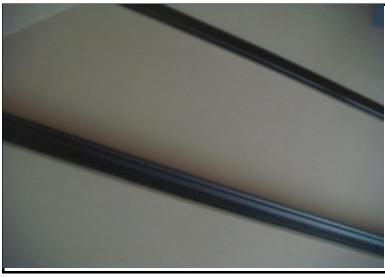
Repair cracked drywall surface at: Master Bedroom Ceiling

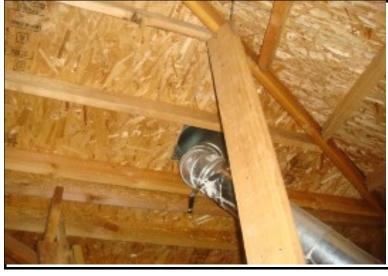
Attic -- Recommend to seal areas where the furnace flues are venting across the roof (found evidence of prior water penetration).

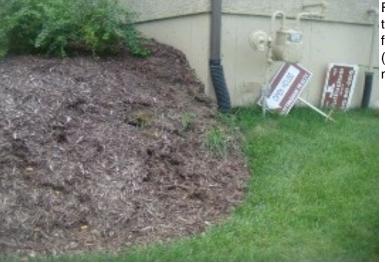
Retaining Walls -- Recommend to build a retaining wall at the front-right corner of the building (lots of soil erosion, surface right now is covered with mulch).

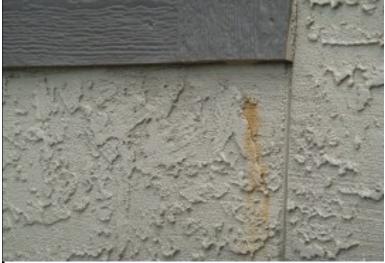
Exterior Walls -- Call an stucco contractor to provide further evaluation and repairs for the orange/corrosion spots at the stucco walls (check the entire perimeter please).

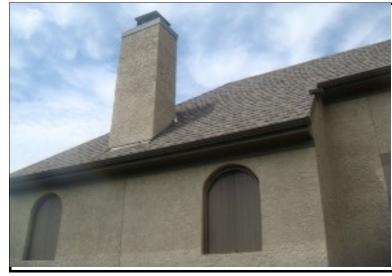
It appears that two wooden windows at the left and right sides of the exterior fireplace were ordered too short respect to the frame or a portion of the window at the exterior is missing.

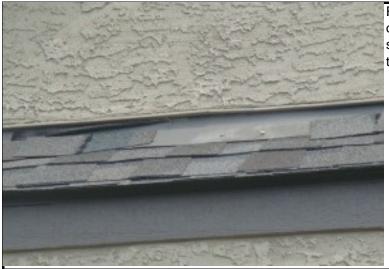
Roof (Low elevation at the back of the hosue) -- Missing two shingles (the ones that go above the metal flashings).
